MERRIAM MOUNTAINS SPECIFIC PLAN

PHASE I ENVIRONMENTAL SITE ASSESSMENT REPORT

PHASE I ENVIRONMENTAL SITE ASSESSMENT REPORT
MERRIAM PROPERTY
ESCONDIDO, CALIFORNIA

Project No. 600197-001

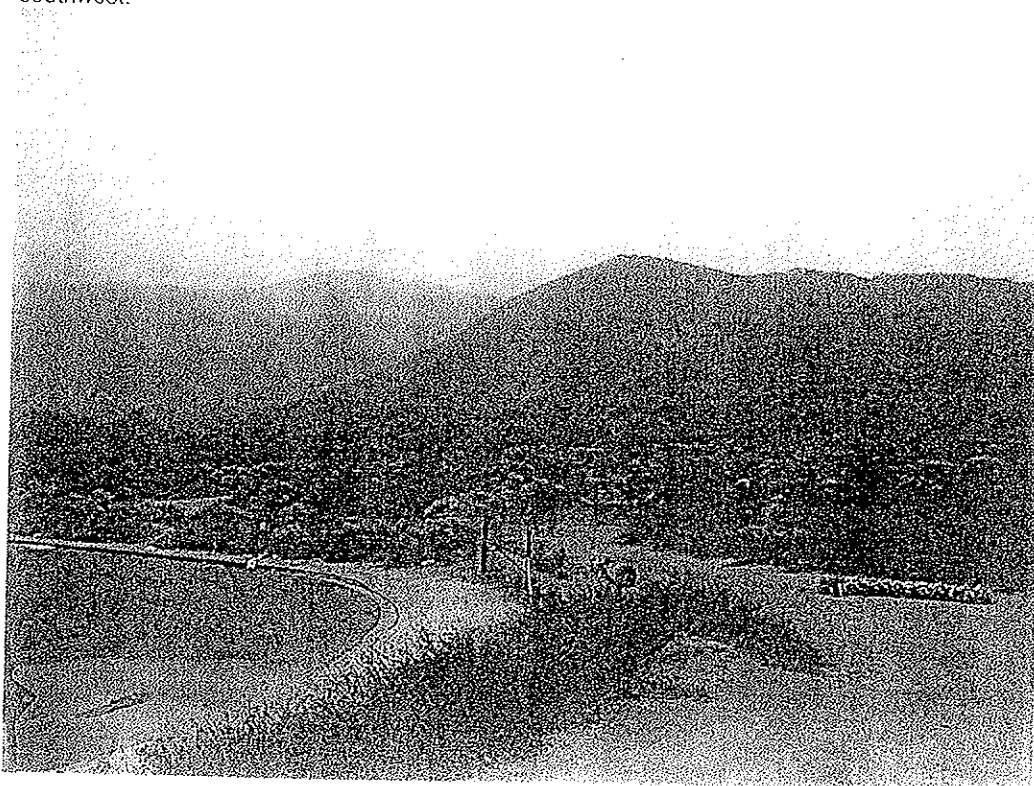
PHOTO NO. 3:

View of the southeastern area of the Site. Highway 15 is shown on the right-hand side of the photo.
View to northwest.

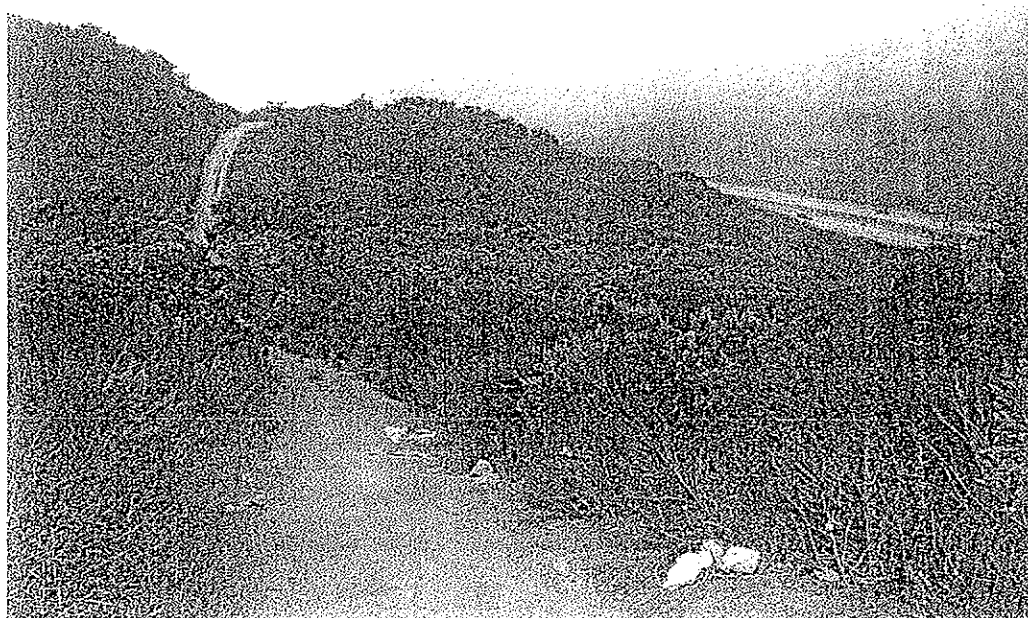
**PHOTO NO. 4:**

View of the southwestern area north of the Specialty Plants nursery. View to north.

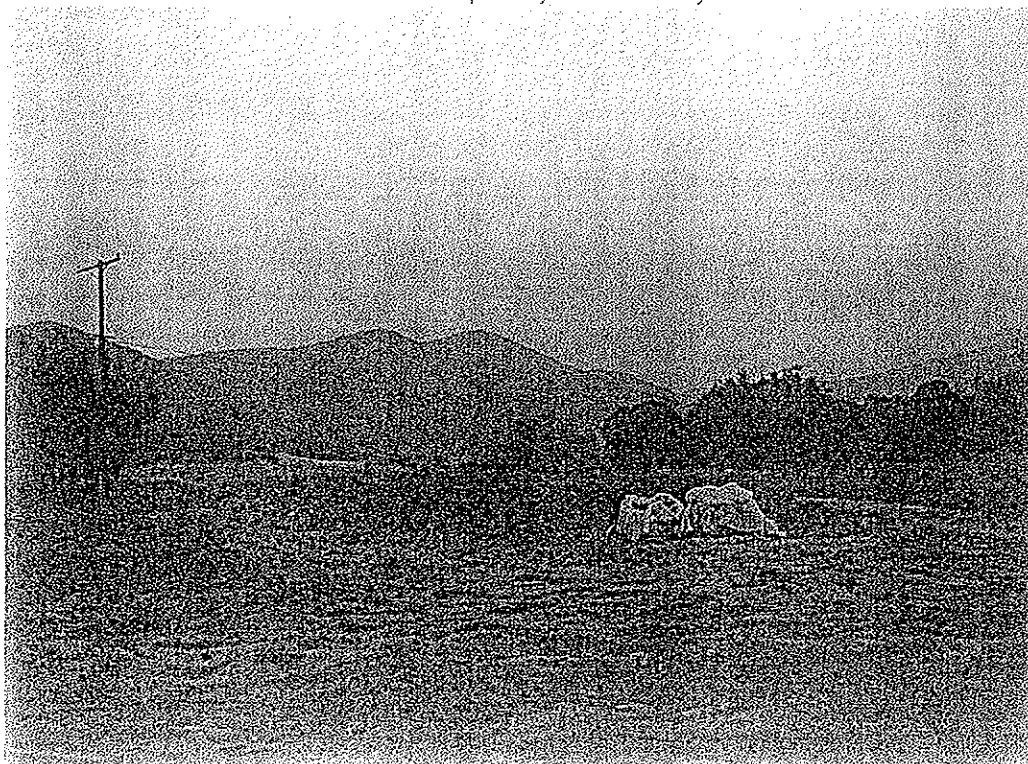
PHOTO NO. 5:

No evidence of underground storage tanks (USTs) (such as vent lines, fill or overfill ports) was observed on the Site. Two aboveground water storage tanks were observed within the Site boundaries in areas that are not a part of the Site. These two tanks are noted on Figure 2 (Photo 5).

View of the south-central area of the Site. View to east.

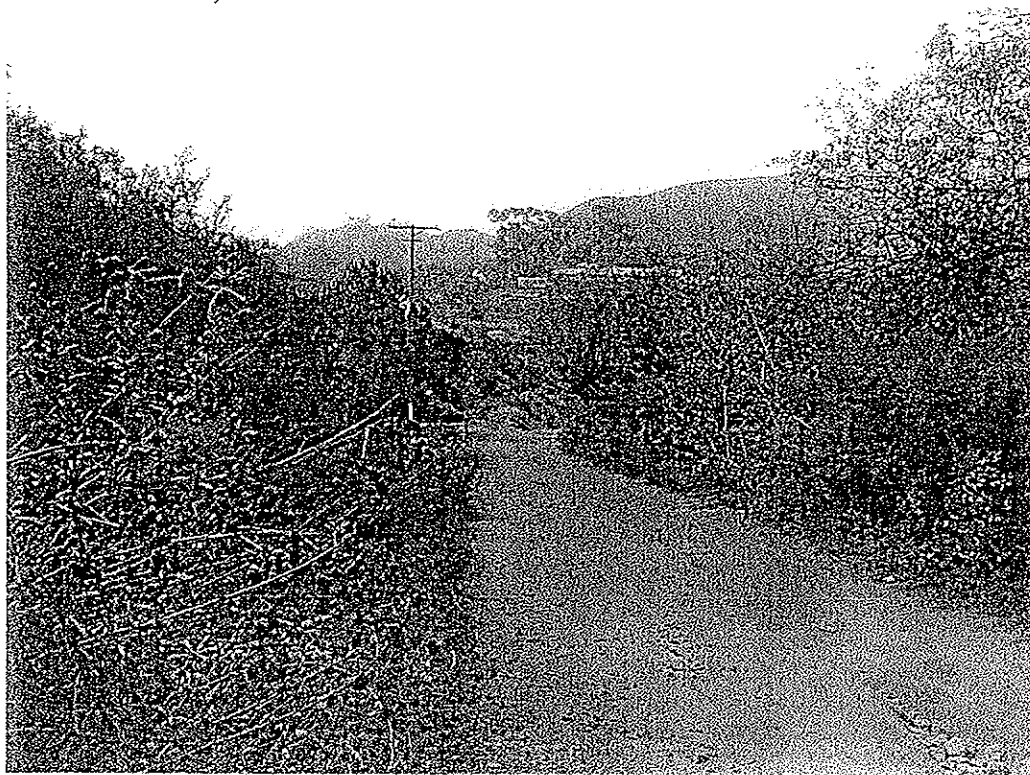
PHOTO NO. 12:

Evidence of cultural debris was observed at several locations onsite. The residential debris was observed at an area south of Camino Mayor (Photo 12) and adjacent to Gist Road on the southwestern area of the Site. Intermittent residential debris was observed at various places at the Site. Stained soils were not noted at the location of this debris.

View of an area of residential on the south side of Camino Mayor. View to southeast.

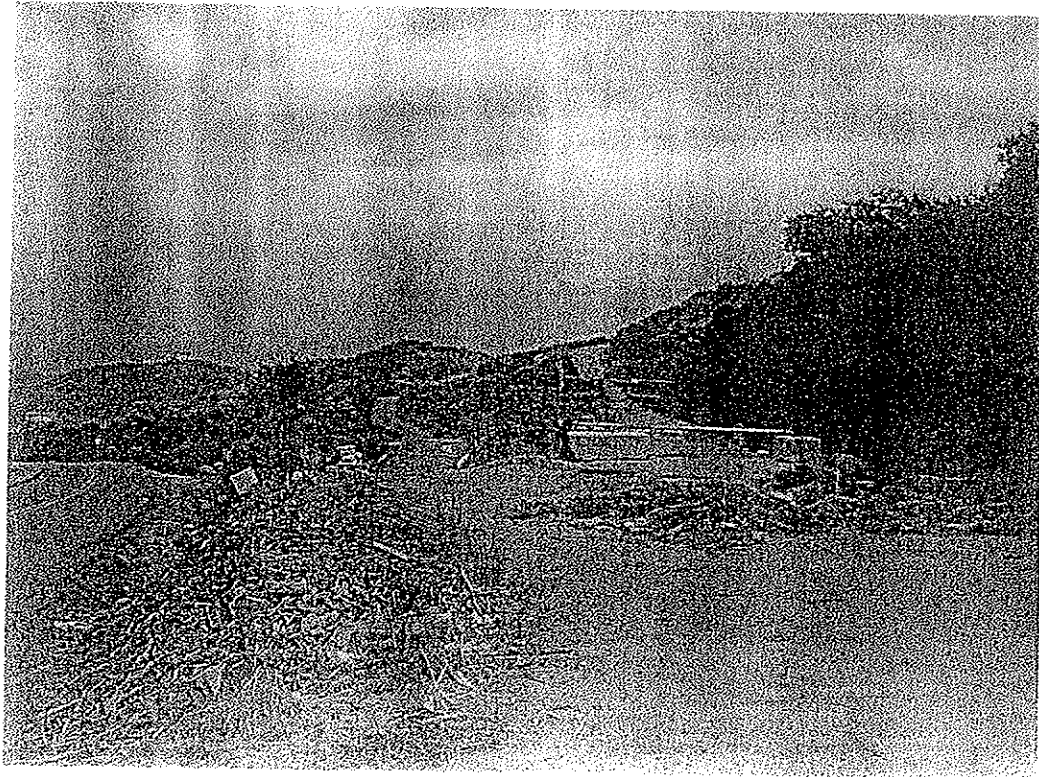
PHOTO NO. 15:

View of the northwestern area of the Site from Huckleberry. View to east.

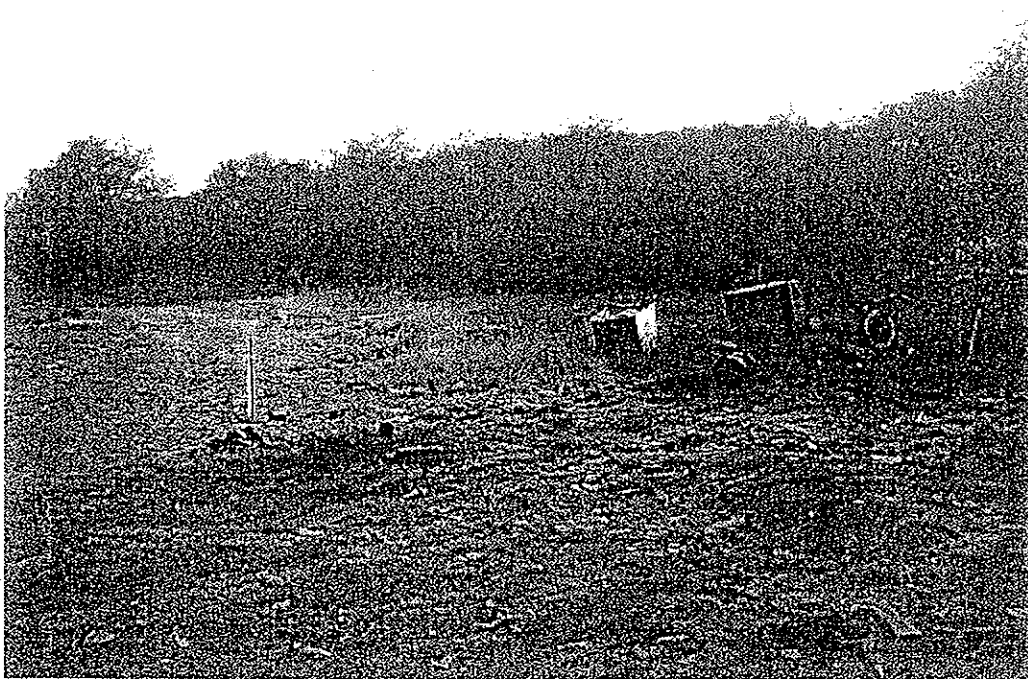
PHOTO NO. 23:

View of the northwestern area of the Site where shell casings were observed.

Leighton Consulting performed a Phase I ESA for the Site in conformance with the scope and limitations of ASTM Practice E1527-00. Any exceptions to, or deletions from, this practice are described in Section 1.5 of this report. Leighton Consulting did not identify any recognized environmental conditions that we believe merit further investigation for the purposes of the transaction for which this assessment was prepared, except for the possible presence of lead shot in the area of the spent shotgun shells northeast of the abandoned private airstrip.

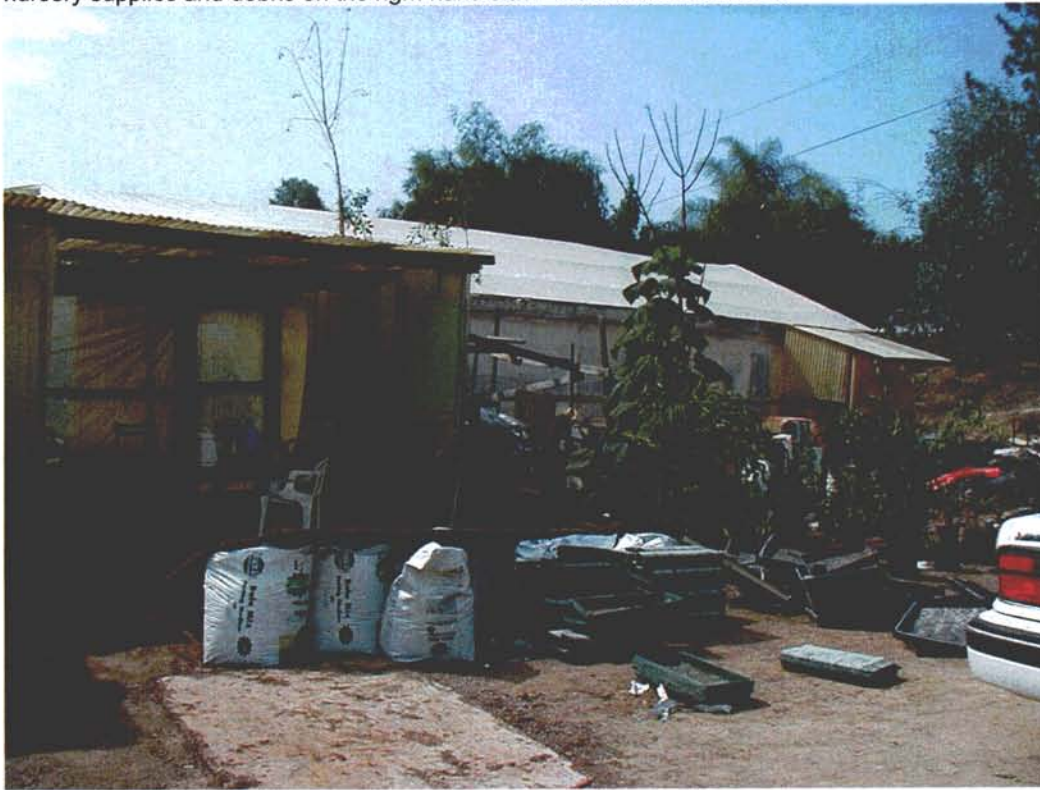
PHOTO NO. 3:

View of the northern end of the green house showing a break/kitchen area on the left-hand side and nursery supplies and debris on the right-hand side. View to the southwest.

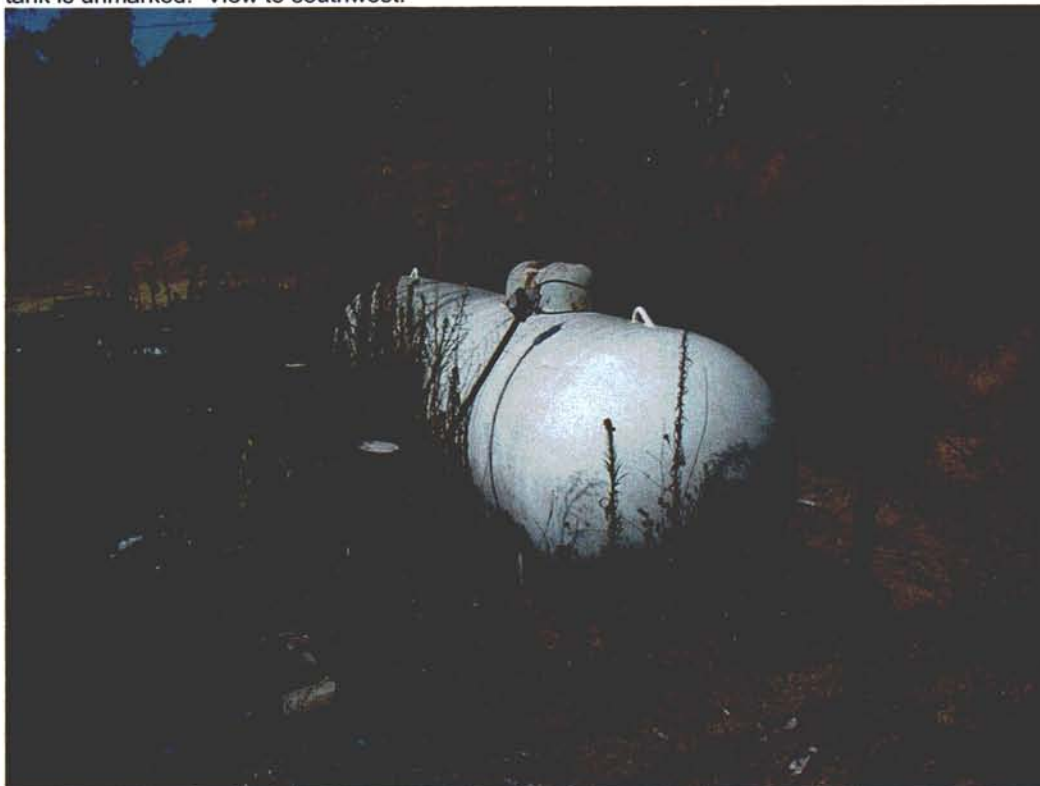
**PHOTO NO. 4:**

No evidence of underground storage tanks (USTs) (such as vent lines, fill or overfill ports) was observed on the Site. One aboveground storage tank was observed and is noted on Figure 2 (Photo 4). The tank was unmarked and, based on Leighton Consulting's experience, may be propane used to heat the greenhouse in the winter.

View of an aboveground storage tank adjacent to the northeast corner of the green house. The tank is unmarked. View to southwest.

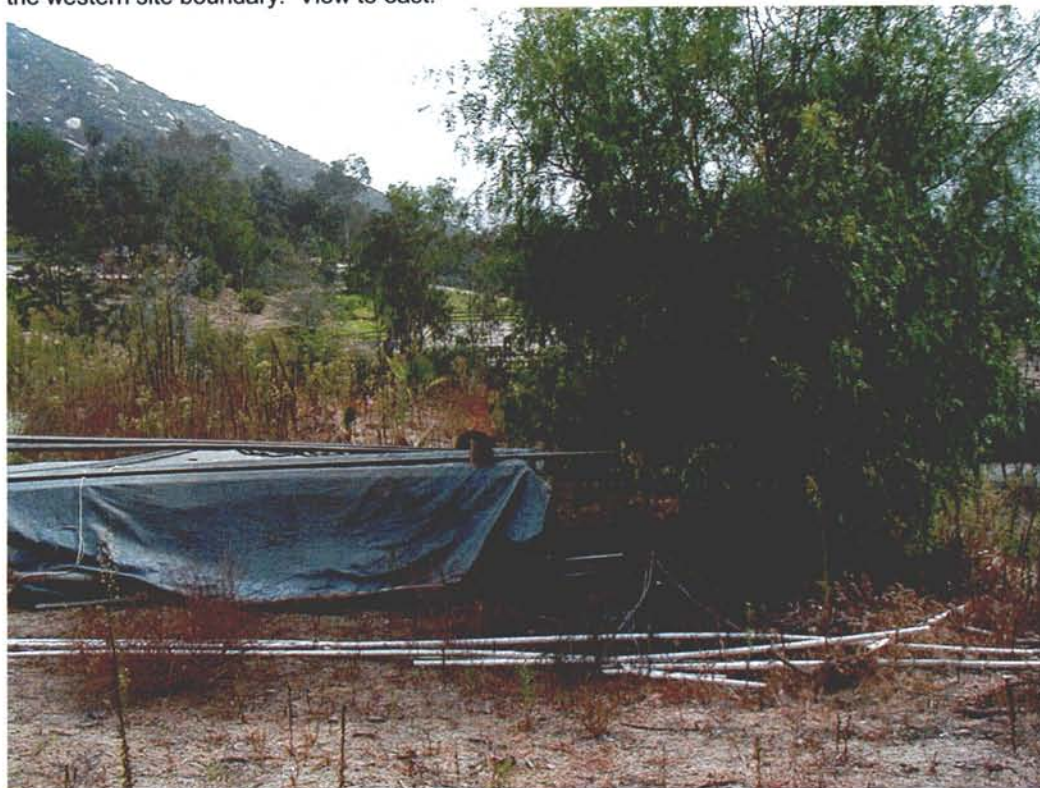
**PHOTO NO. 8:**

View of the central area of the Site showing plastic pipes and other nursery-related items adjacent to the western site boundary. View to east.

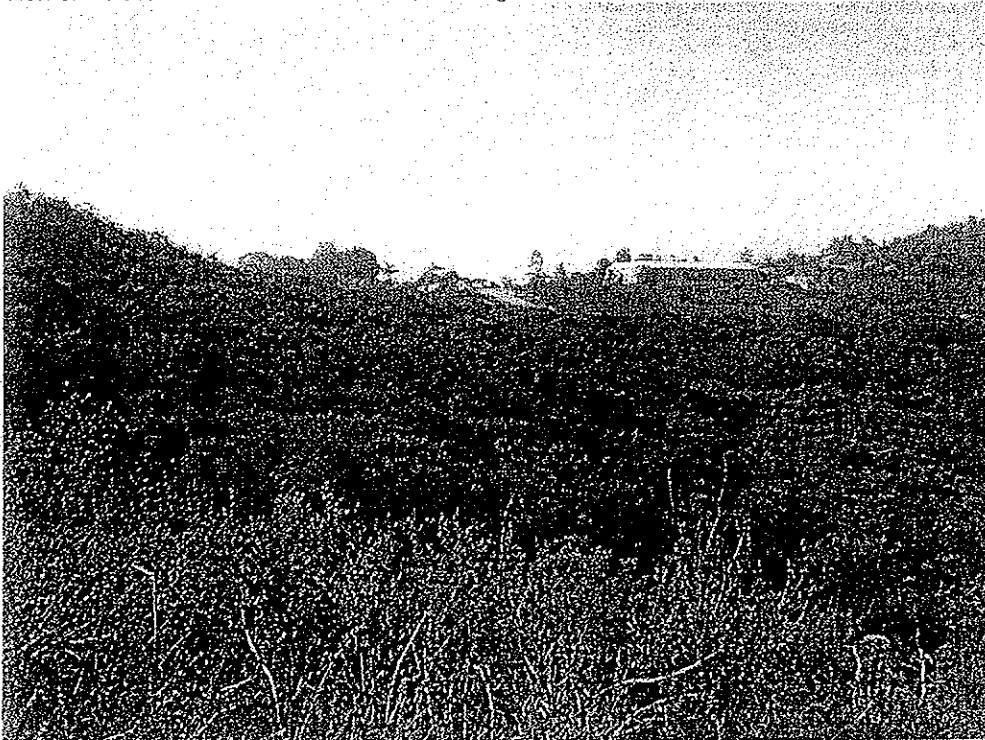
PHOTO NO. 4:

The Site is currently bordered by undeveloped properties to the north, east and west and two structures were noted to the south of the Site (Photo 4).

View of the southeastern area of the Site, showing a structure south of the Site. View to southwest.

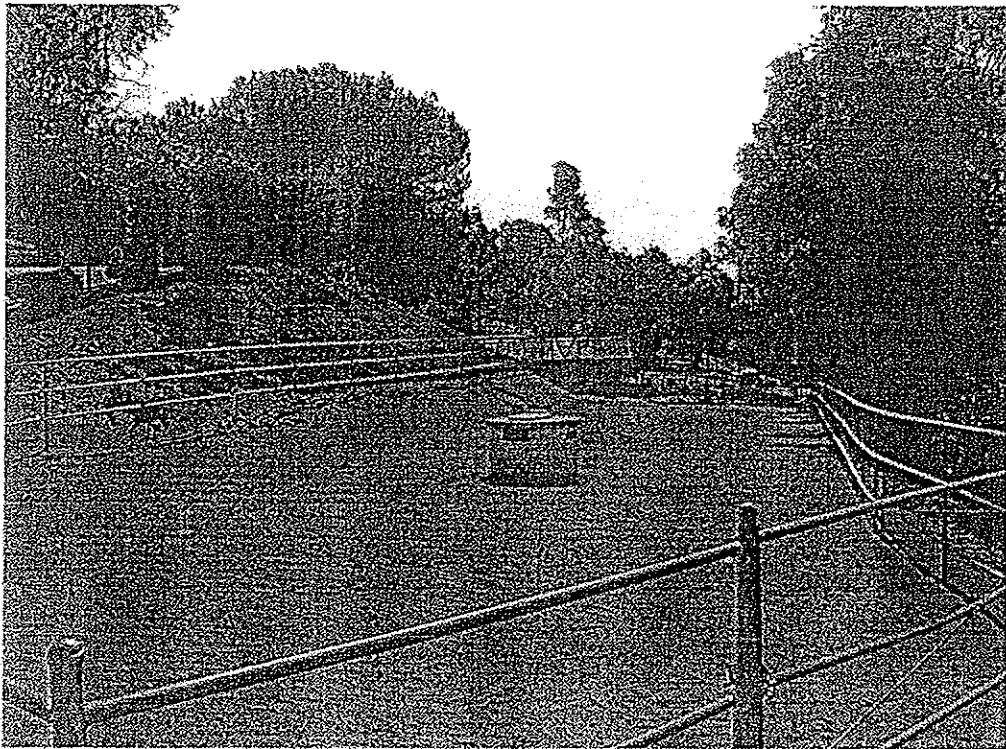
PHOTO NO. 4:

Adjoining properties are a mix of residential and commercial use. The north boundary of the Site is bordered by residential property with horses. A vent for the San Diego aqueduct is present on this property (Photo 4). The southern border of the Site is Deer Springs Road followed by commercial property. The east border of the property is residential use (Photo 8). The western boundary is bordered by a commercial property (Photo 13) Photos are provided in Appendix B.

View of north adjacent property, San Diego Aqueduct vent in middle of the horse corral.

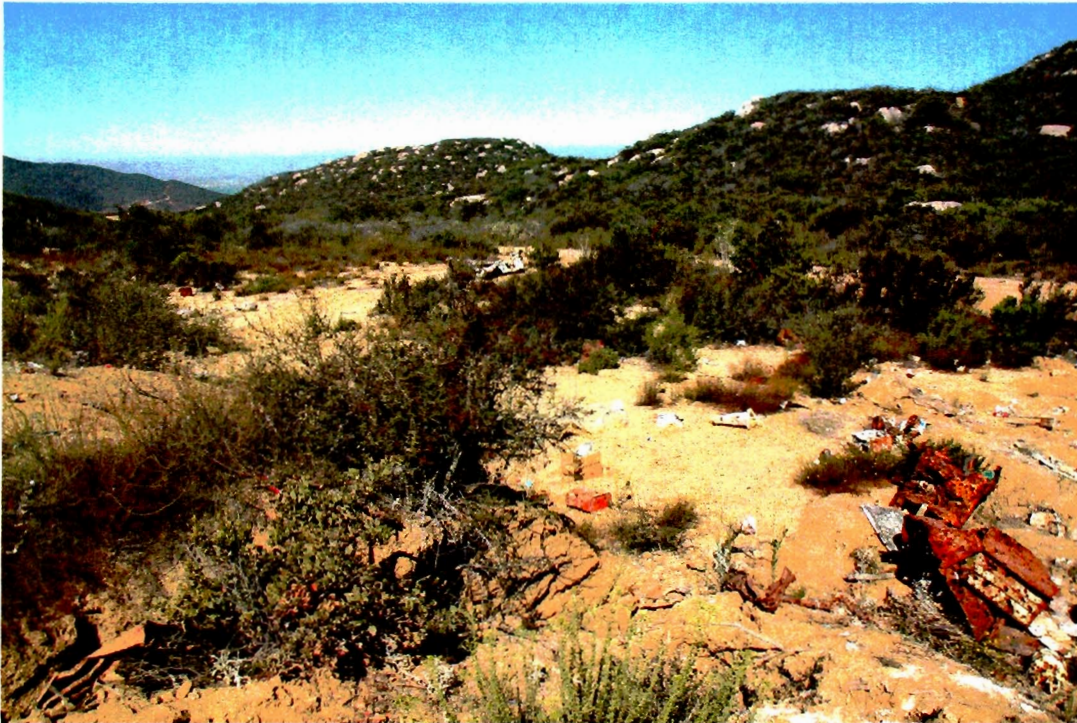
PHOTO NO. 1:

On August 31, 2006, Leighton was onsite to collect four (4) surface soil samples from the area of spent shotgun shells. The approximately 500 spent shot gun shells and approximately less than 50 22-bullet casings were noted in an approximately 120 feet by 120 feet area with cultural debris (metal, computer screen and compute CPU, etc.) that appears to have been used for target shooting by trespassers (Appendix A – Photographs). The four (4) soil samples were collected adjacent metal debris, which appears to have been used a targets. The four (4) soil samples locations are noted in Photographs #4, 5, 6, 7 and 8, which are presented in Appendix A. The soil sample locations are shown on Figure 2.

View of area with spent shotgun shells. View facing northwest.

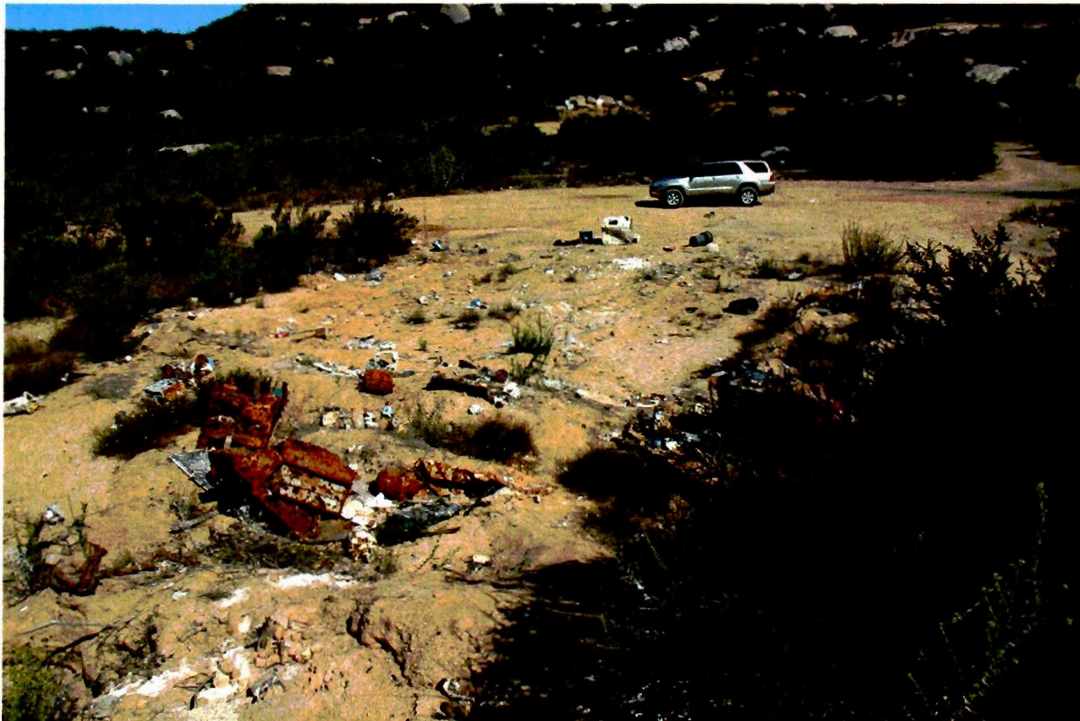
PHOTO NO. 2:

View of area with spent shotgun shells. View facing north.

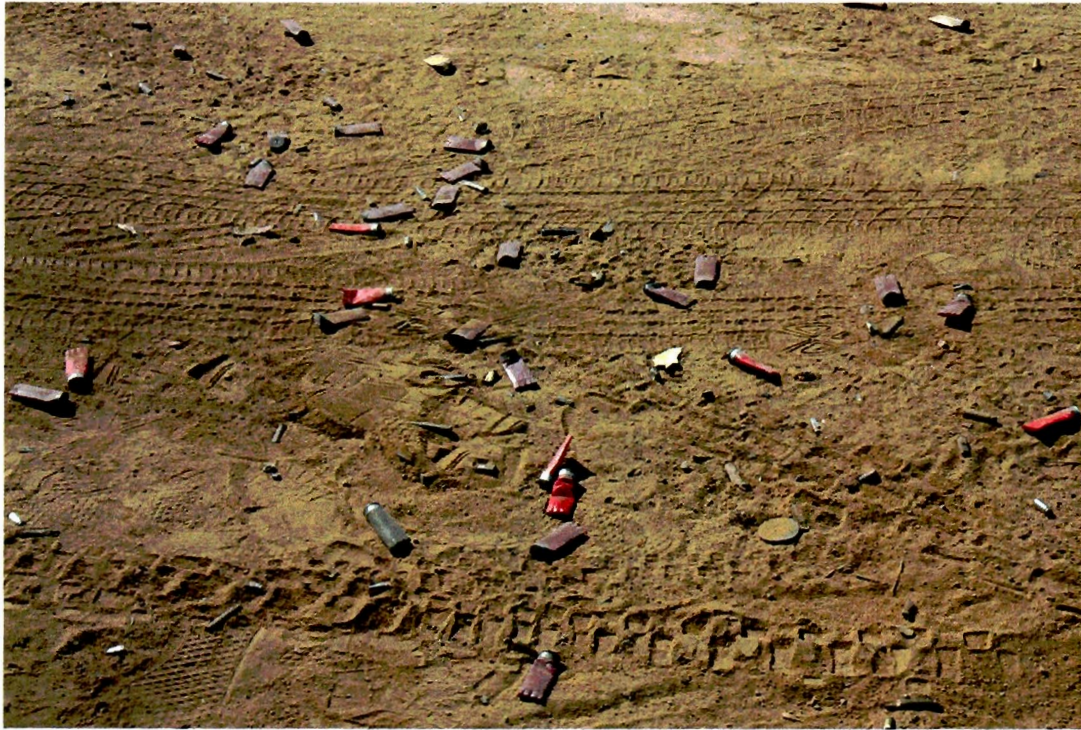
PHOTO NO. 3:

View of area with spent shotgun shells adjacent to dirt road.

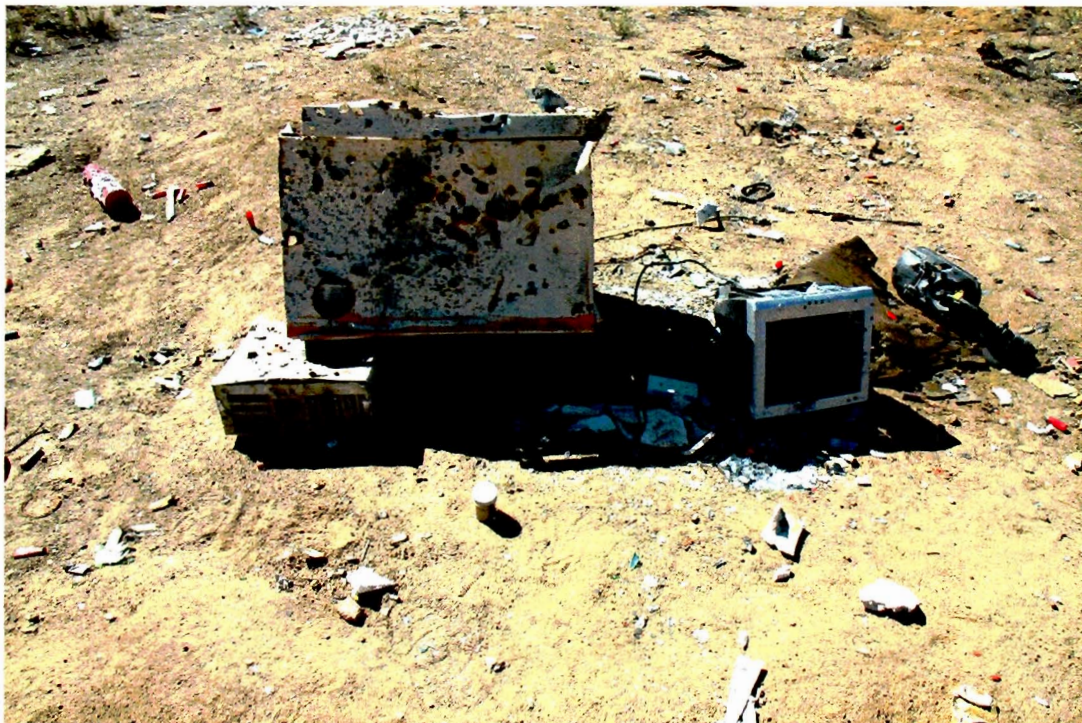
PHOTO NO. 4:

View of sample number S-1 in area with spent shotgun shells. View facing south.

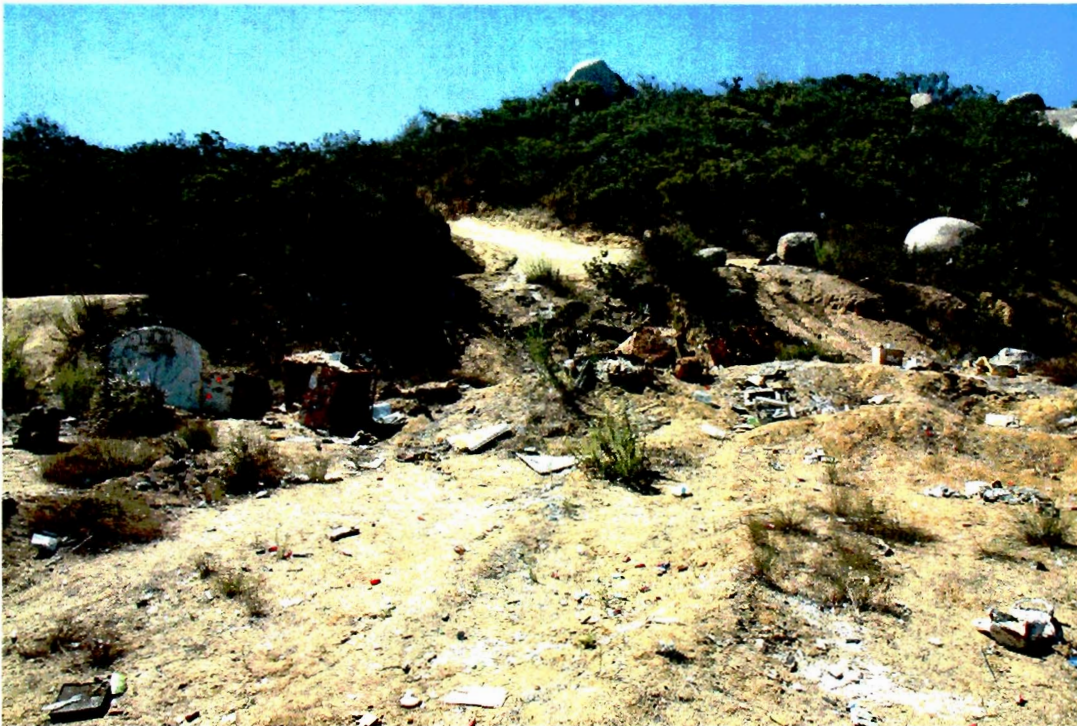
PHOTO NO. 5:

View of samples numbers S-2 and S-3 in area with spent shotgun shells. View facing south.

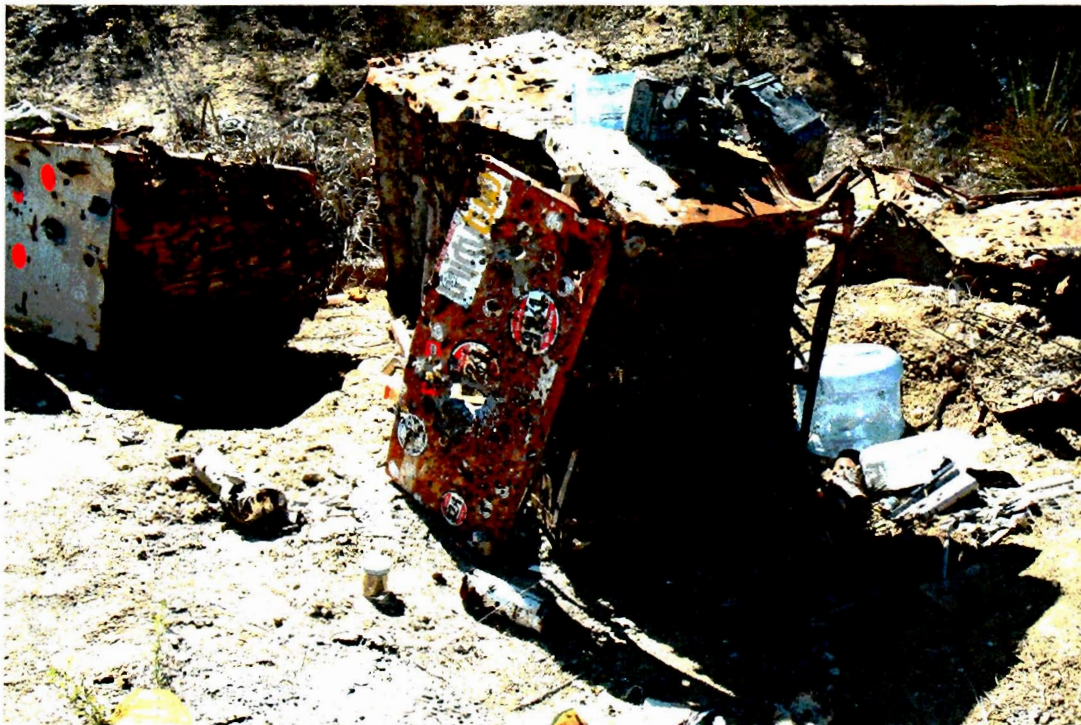
PHOTO NO. 6:

View of sample number S-2 in area with spent shotgun shells. View facing south.

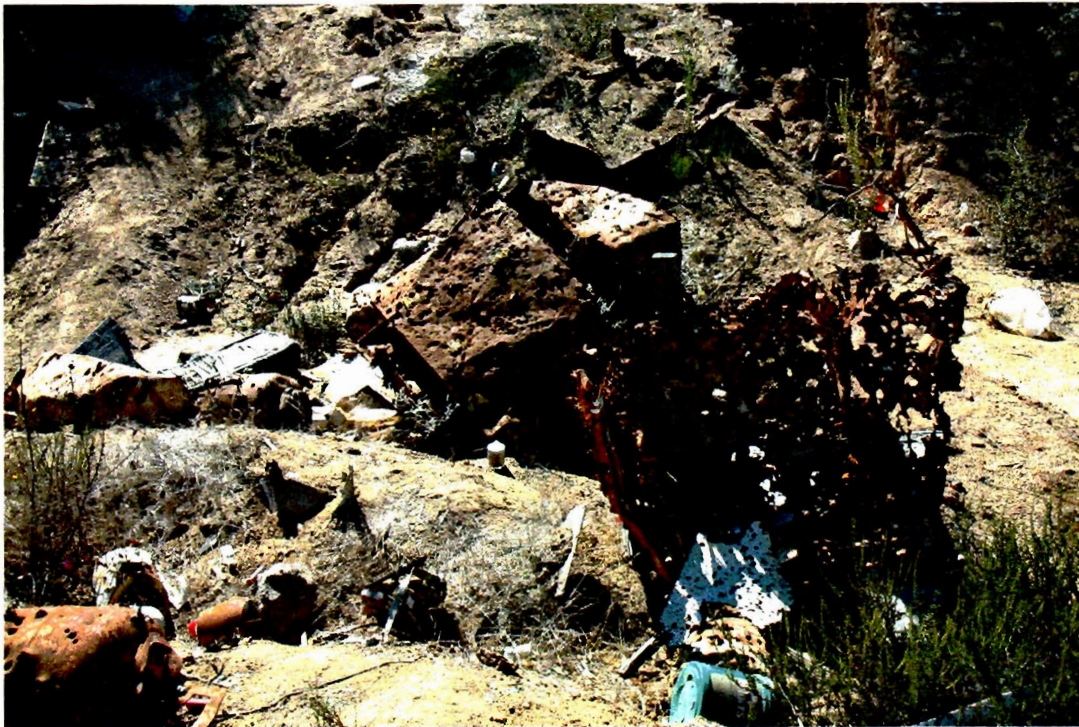
PHOTO NO. 7:

View of sample number S-3 in area with spent shotgun shells. View facing south.

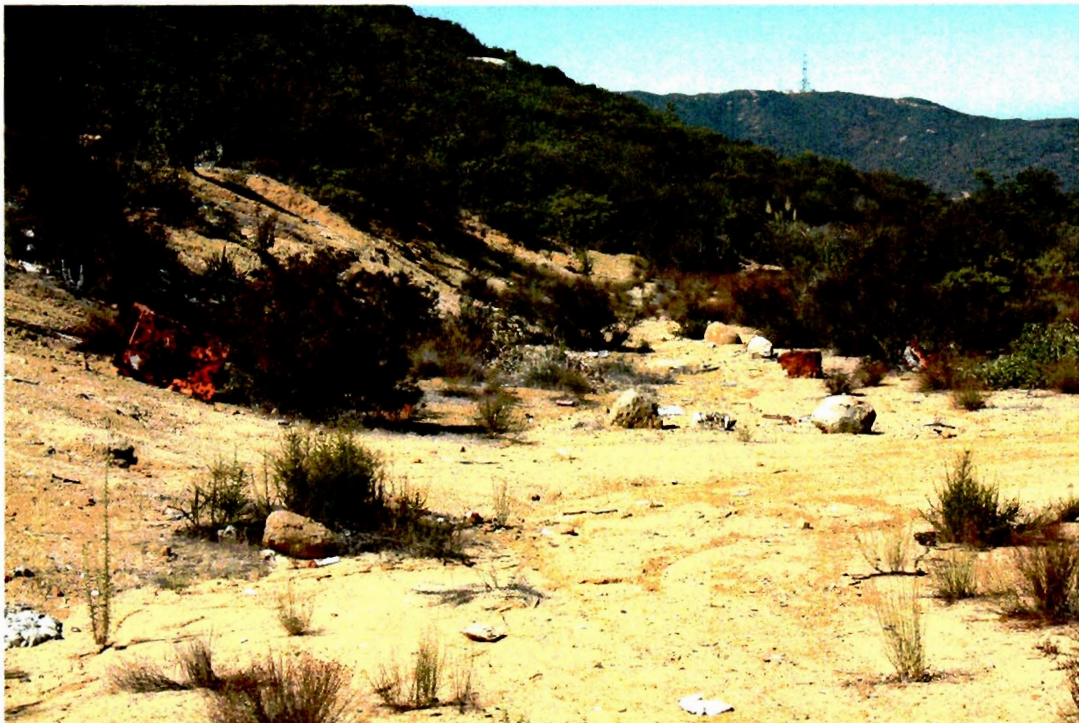
PHOTO NO. 8:

The surface soil in the area of the spent shotgun shells has been impacted with lead from shotgun and bullet shells at concentration above the California standard for hazardous waste of 1,000 mg/kg for Total Lead and 5 mg/L for soluble lead and above the RCRA standard for hazardous waste of 5.0 mg/L.

View of sample number S-4 in area with spent shotgun shells. View facing southwest.

Based on the elevated levels of total and soluble lead in the four (4) surface soil samples collected from the area of spent shotgun shells we recommend the following:
